Review of Long-Term Maintenance Plans for the South Jetty, Grays Harbor, Washington

Final report

Prepared for U.S. Army Engineer District, Seattle
Seattle, WA 98124-2255

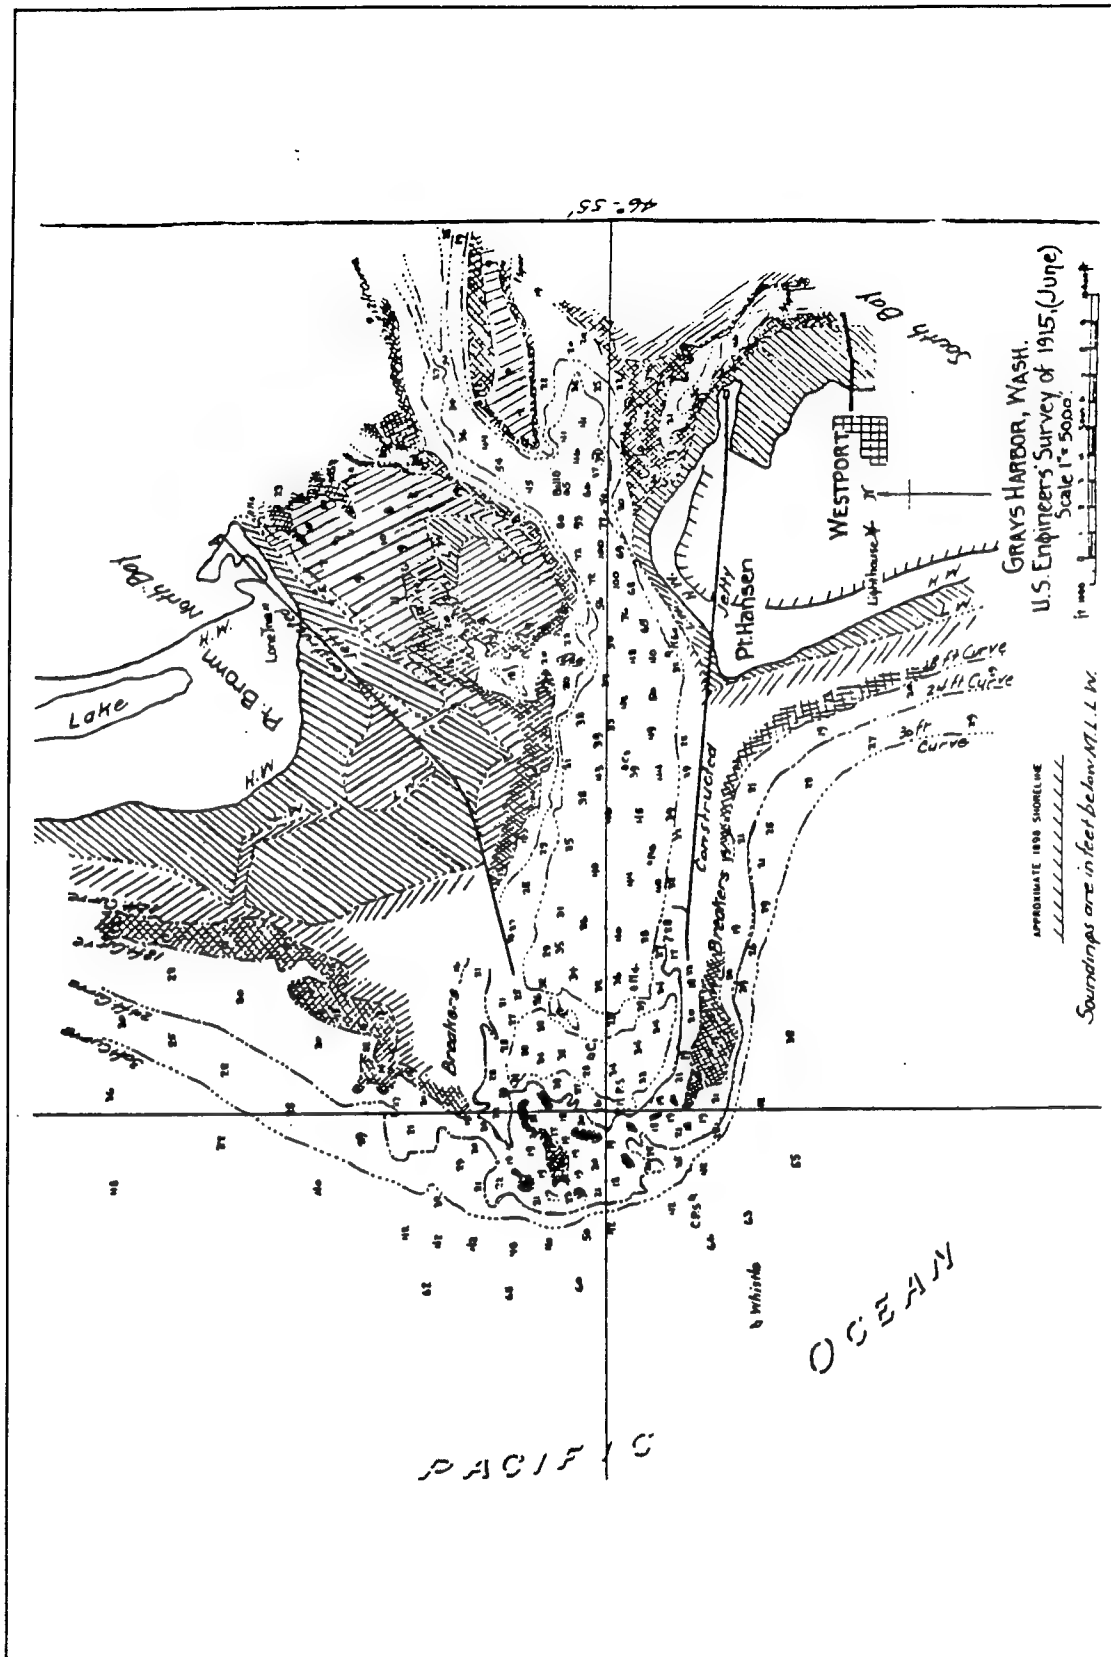
Figure 3. Entrance configuration on completion of jetties

15. Figure 3 shows the configuration of the entrance in 1915, the time when the jetties were nearly completed. The entrance channel is broader than the channel was prior to construction, shown in Figure 2, and has about the same depth. It emerges near the center of the outer ends of the jetties. Material had been scoured from the entrance and deposited on the outer bar. Sand was deposited along the south side of the south jetty (then 13 years old).

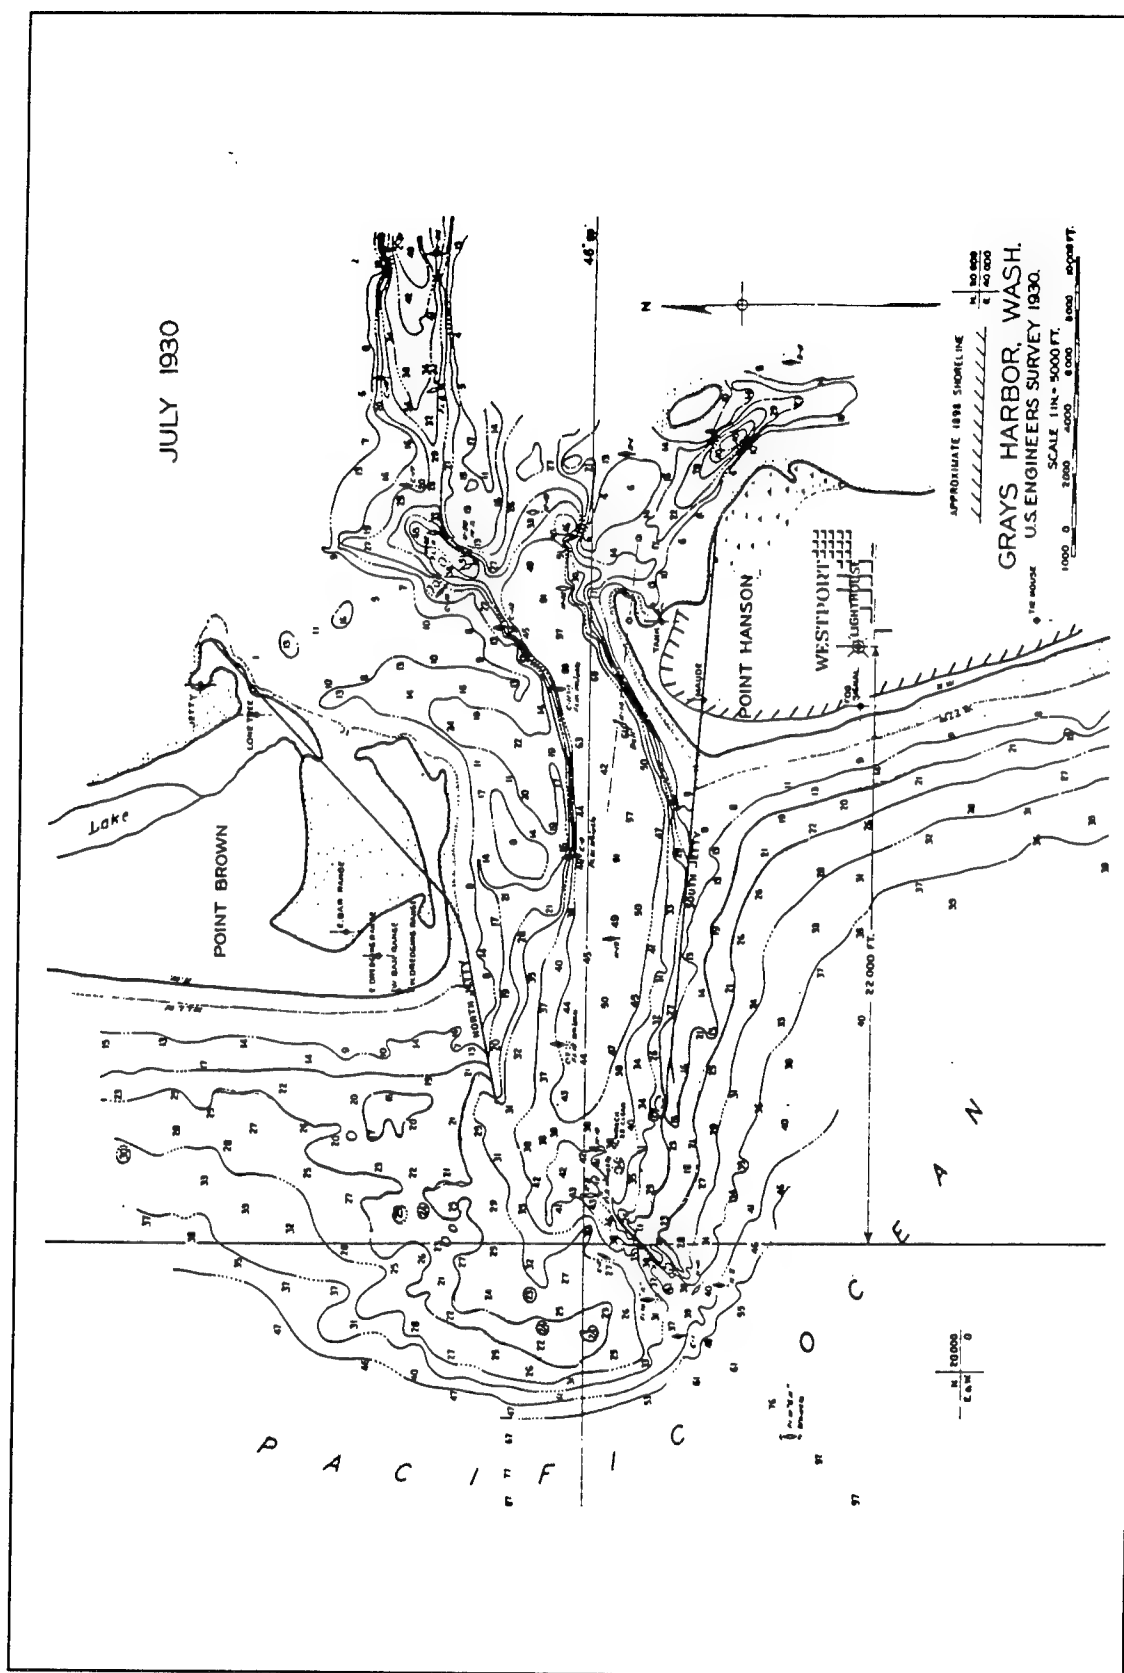
Figure 4. Entrance configuration in 1930

16. Figure 4 shows the configuration of the entrance in 1930. Comparison with Figure 3 shows that the entrance channel is deeper but narrower, and the north side of the entrance channel has moved south. Depths of water over the outer bar were greater, and Point Brown extended further south and west. The west shore of Point Hanson (South Beach) was eroded.

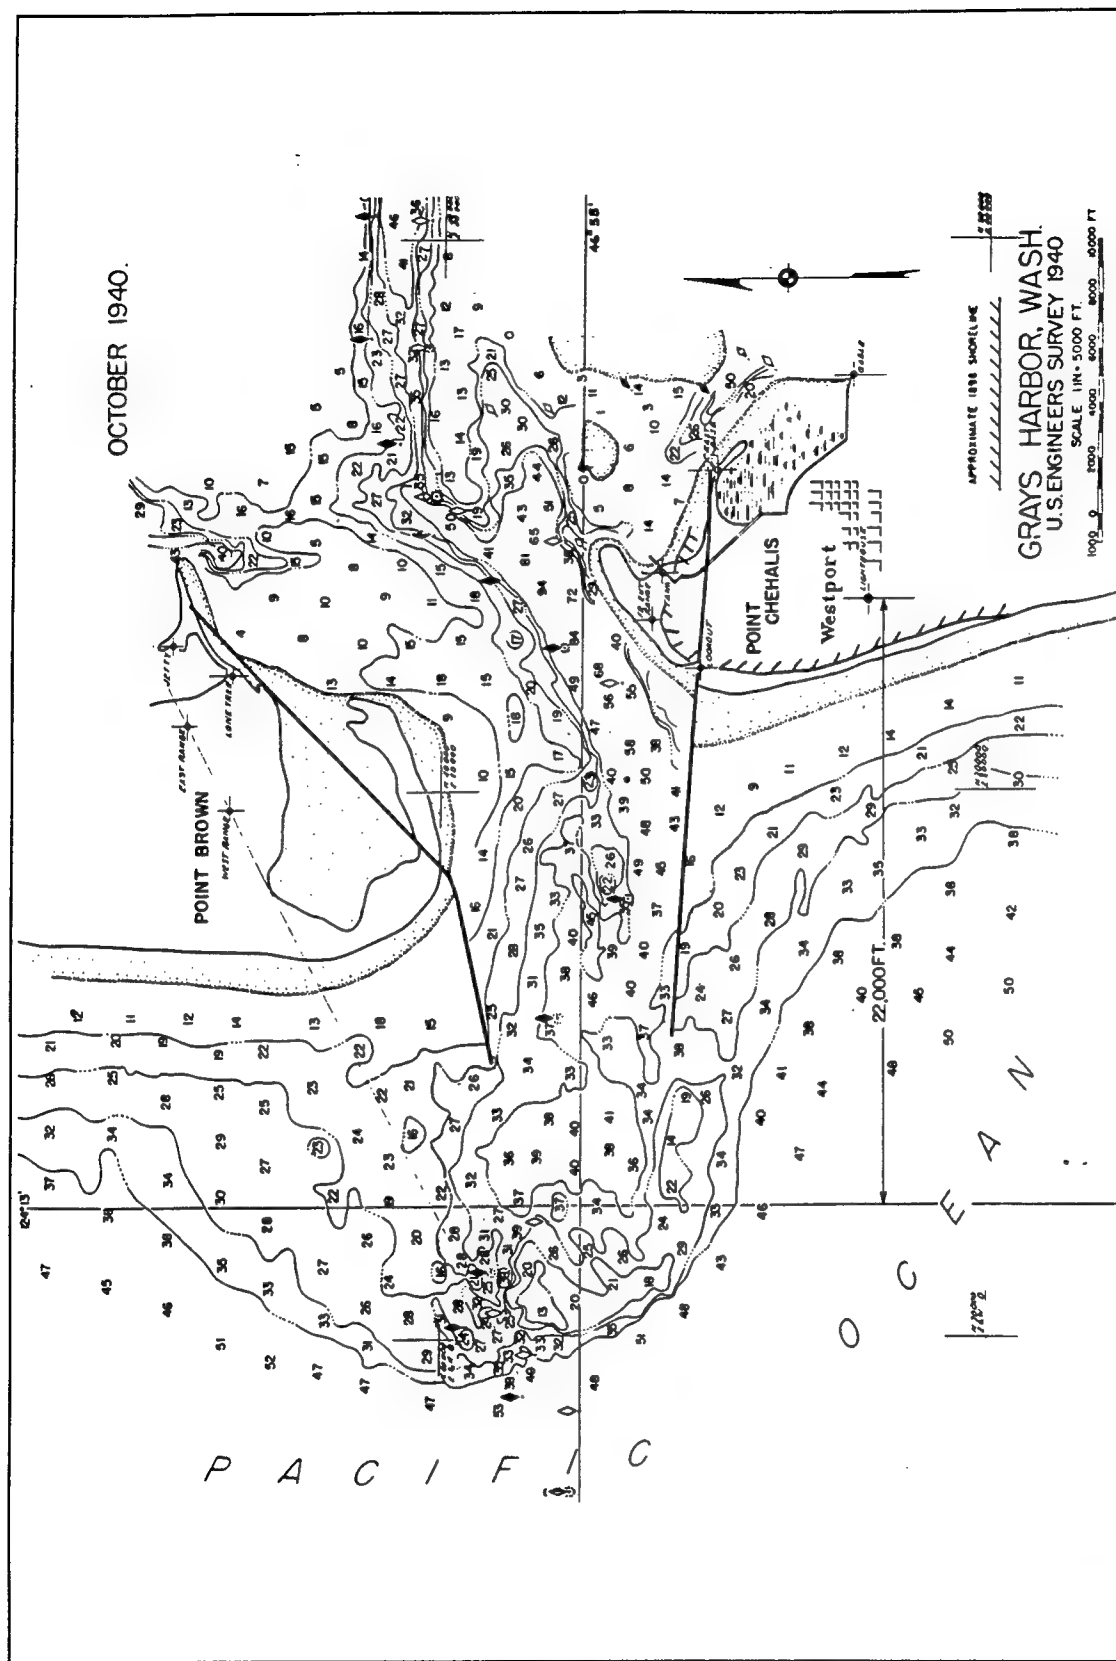
Figure 5. Entrance configuration in 1940

17. Figure 5, showing the configuration of the entrance in 1940, indicates a continuation of the trends described above. The entrance channel was hard against the south jetty and still narrower than it was in 1930. The inner bar deposit south of the north jetty, across the jetty from Point Brown, has accumulated more sediment, as had the deposit at the north tip of Point Hanson -- now Point Chehalis. South Beach was eroded further.

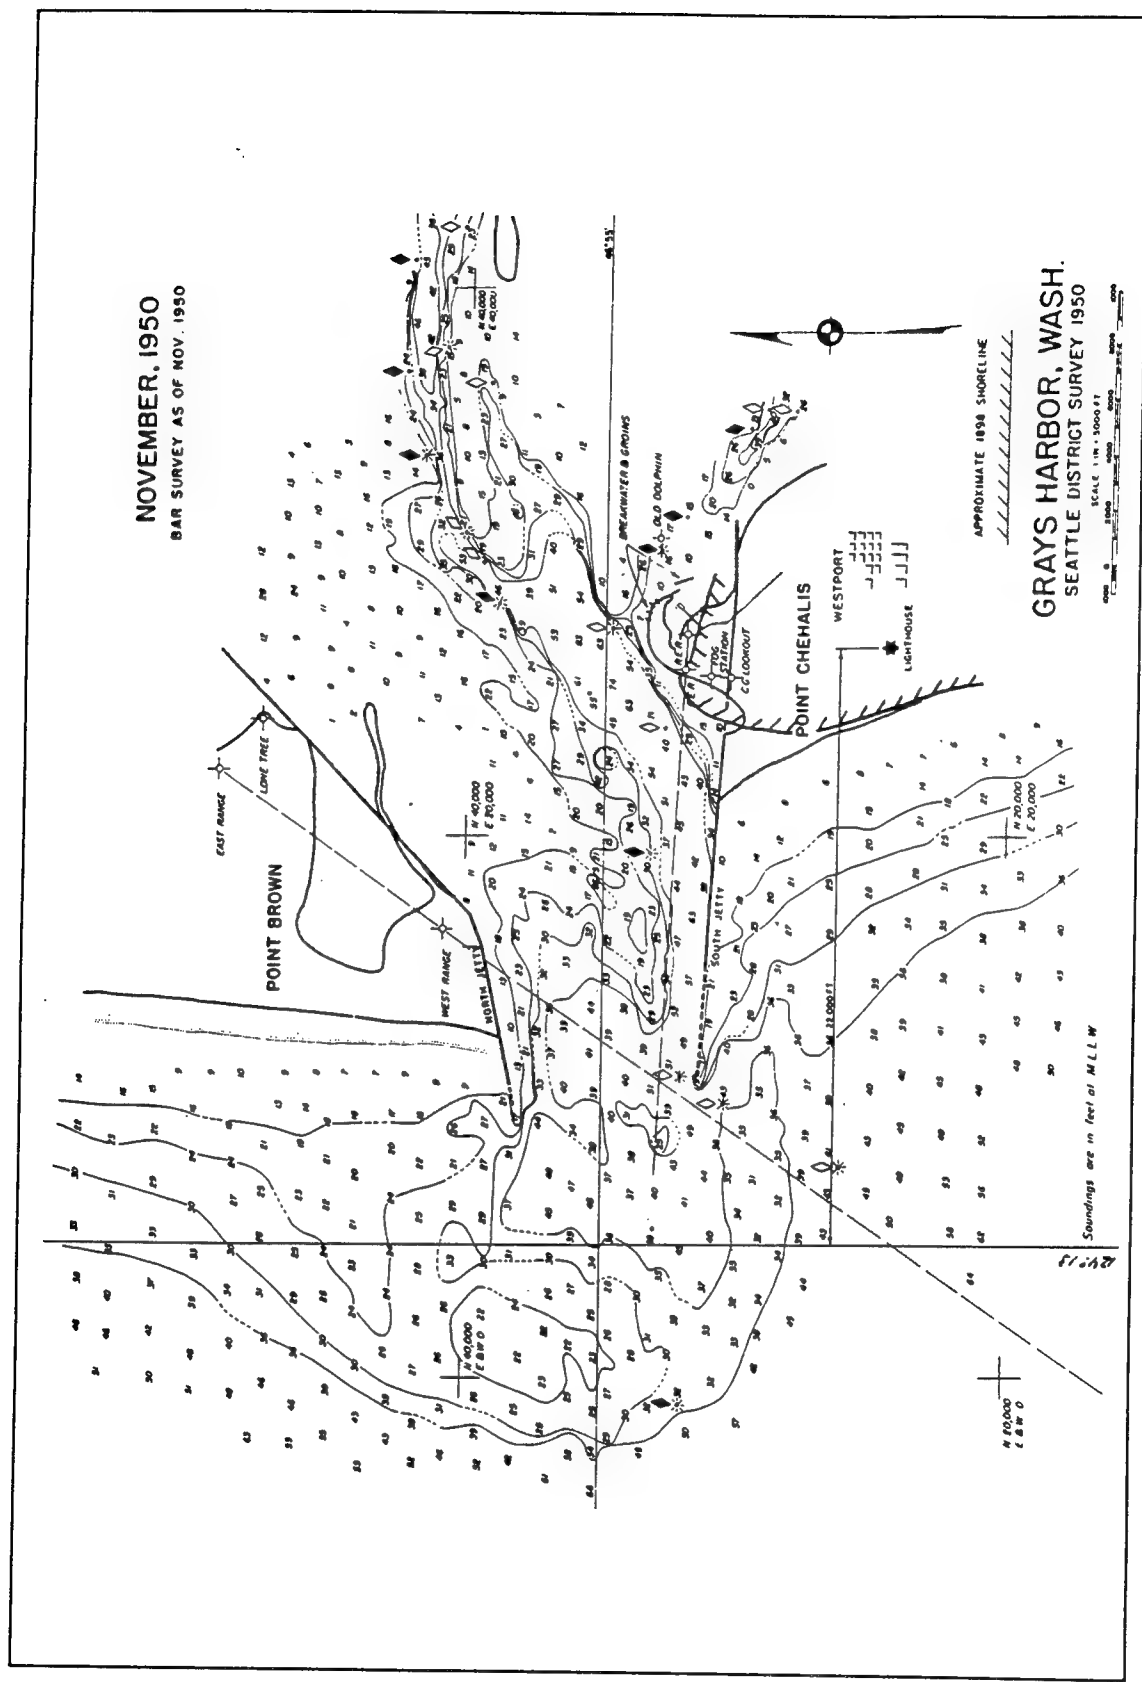
Figure 6. Entrance configuration in 1950

18. Figure 6, dated 1950, shows continuing evolution as described above. The entrance channel was still narrower and deeper, the inner bar deposit north of the channel had accumulated more sediment, and North Beach on Point Brown had advanced toward the outer end of the north jetty. It appears that there was some deposition at the north end of South Beach. This plot shows the first indication of erosion at the east end of the south jetty and of the Point Chehalis shoreline.

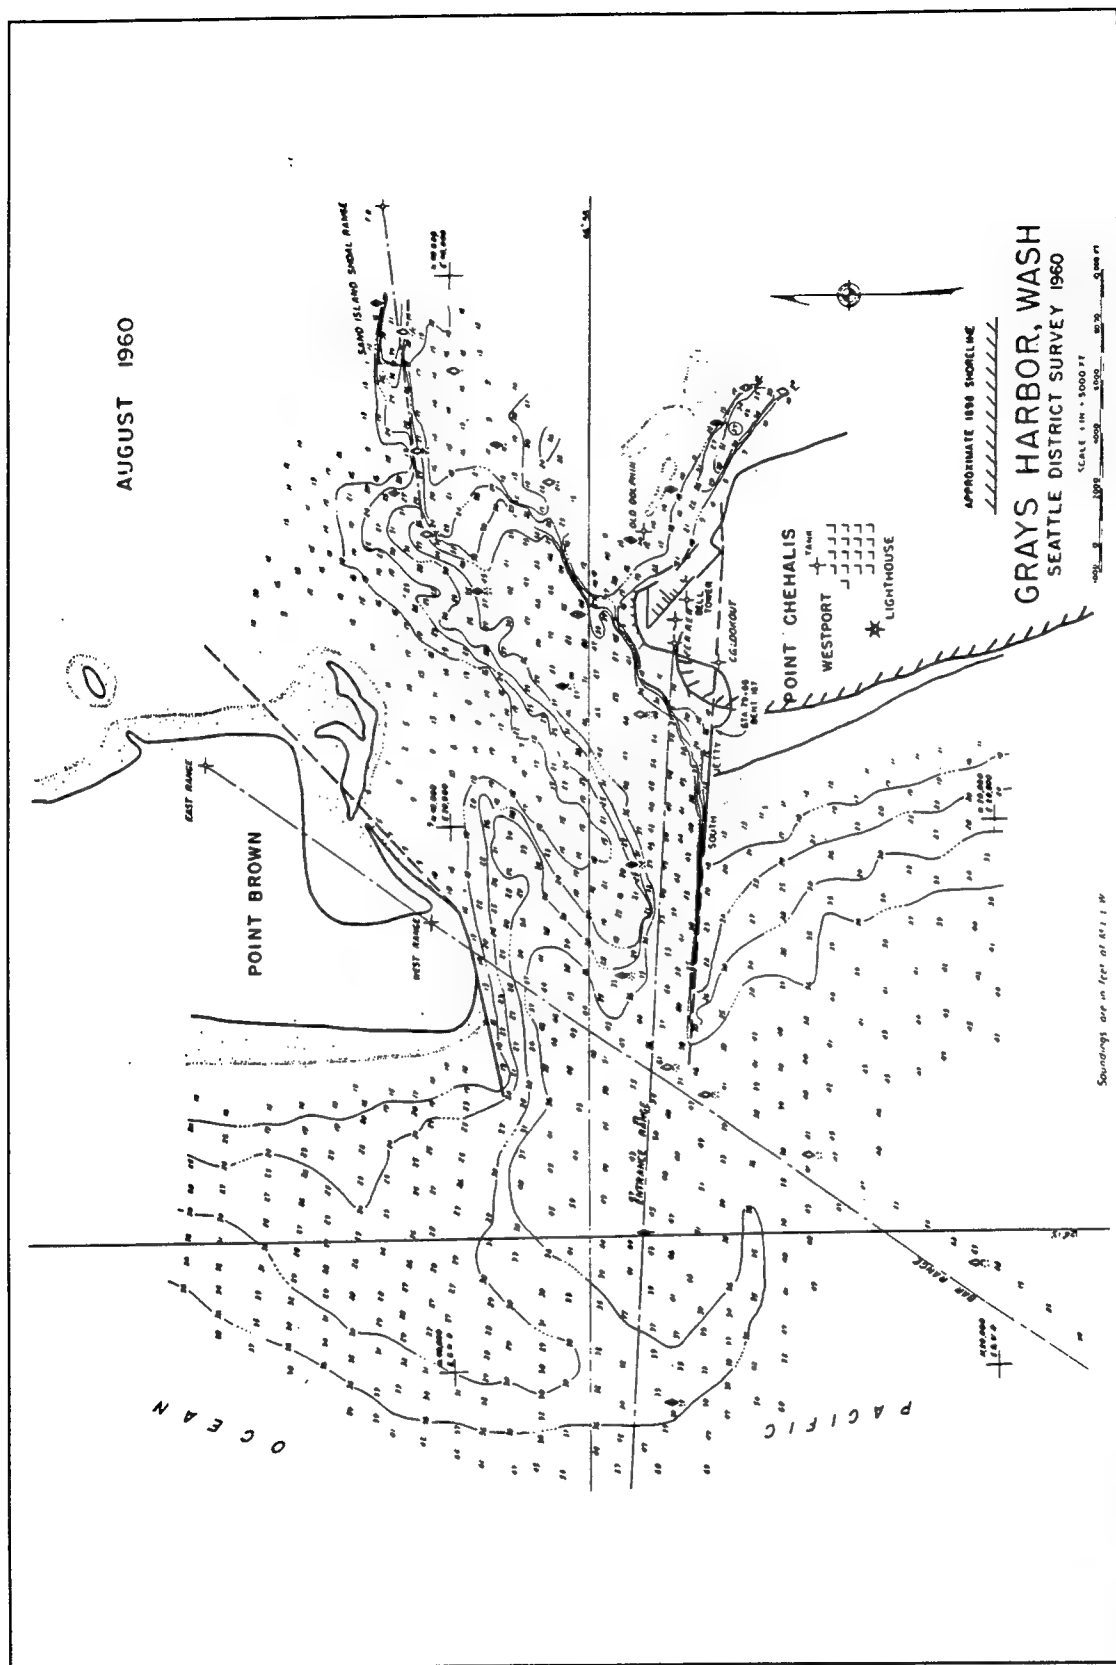
Figure 7. Entrance configuration in 1960

19. Figure 7, dated 1960, when compared with Figure 6, shows erosion of the outer bar and widening of the entrance channel. There was slight erosion of North Beach and some deposition on South Beach. Erosion at the east end of the south jetty had progressed, forming Half Moon Bay. Further erosion of the Point Chehalis shoreline had occurred.

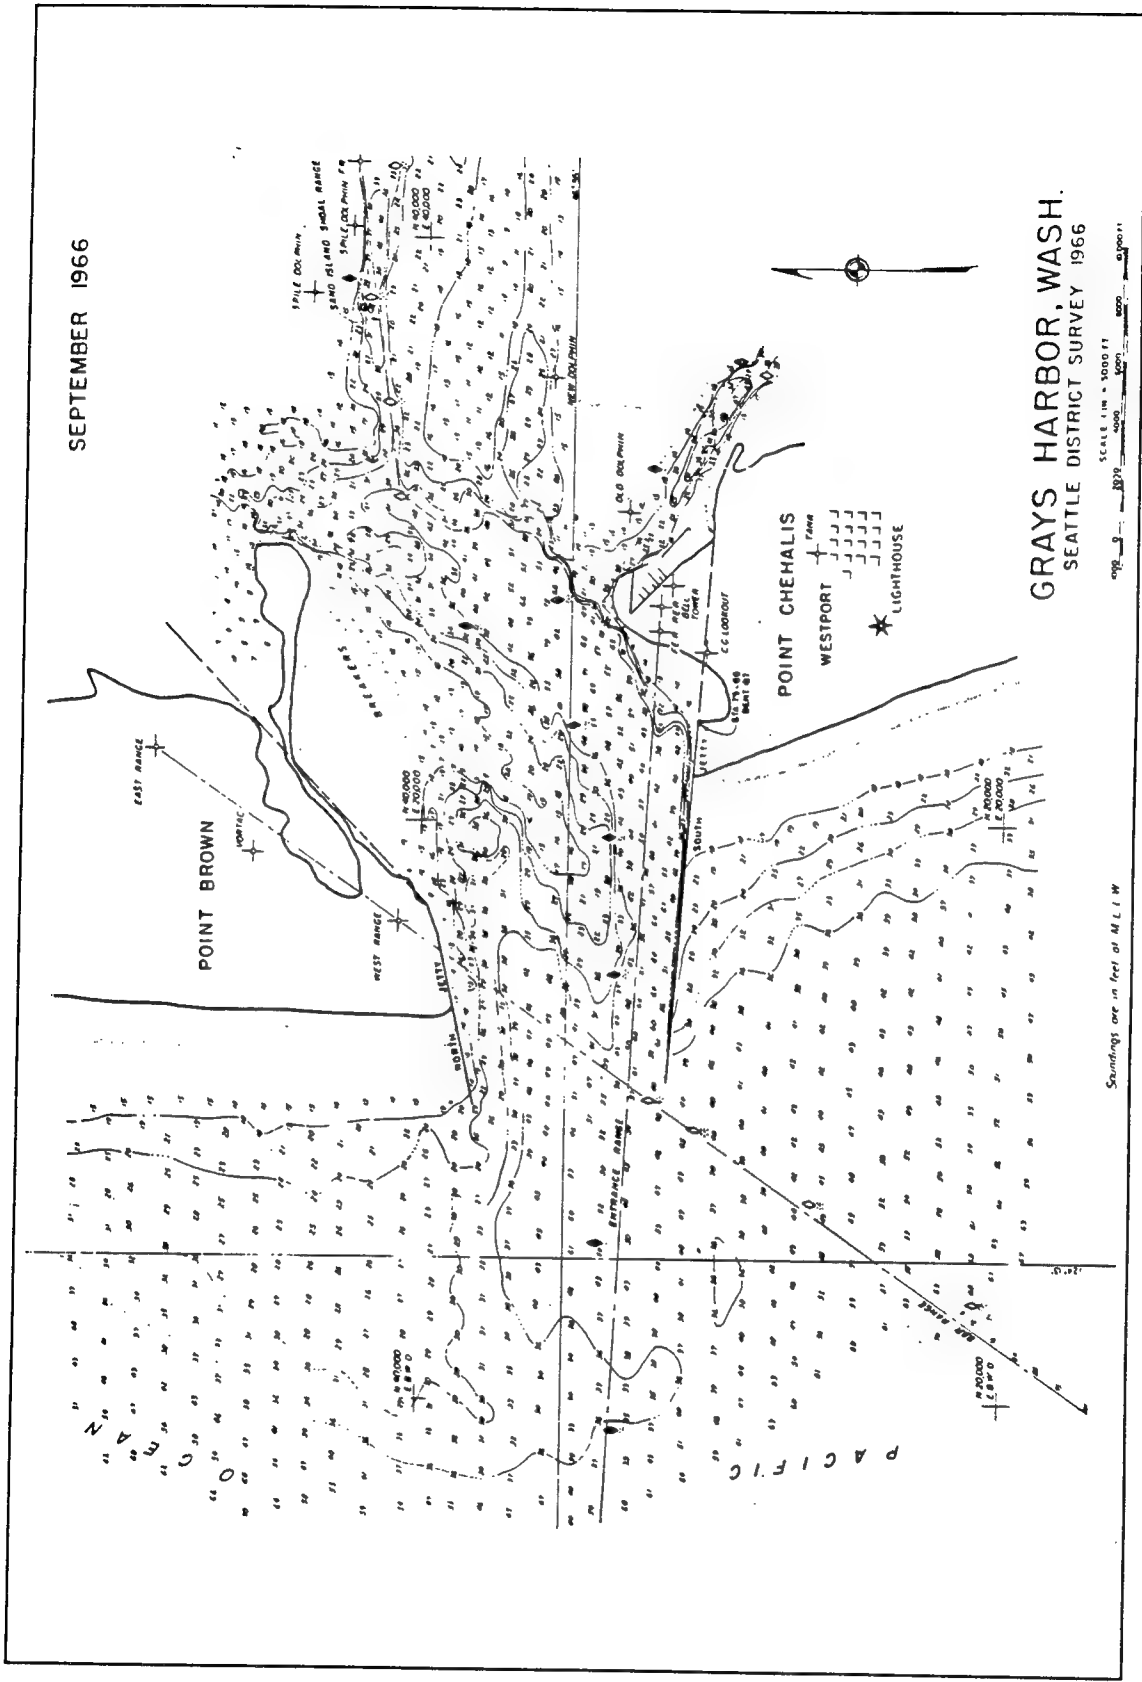
Figure 8. Entrance configuration in 1966

20. Figure 8, dated 1966, when compared with Figure 7, shows additional deposition on the inner bar deposit south of the north jetty and some erosion of the east shore of Half Moon Bay. There was further erosion of the outer bar.

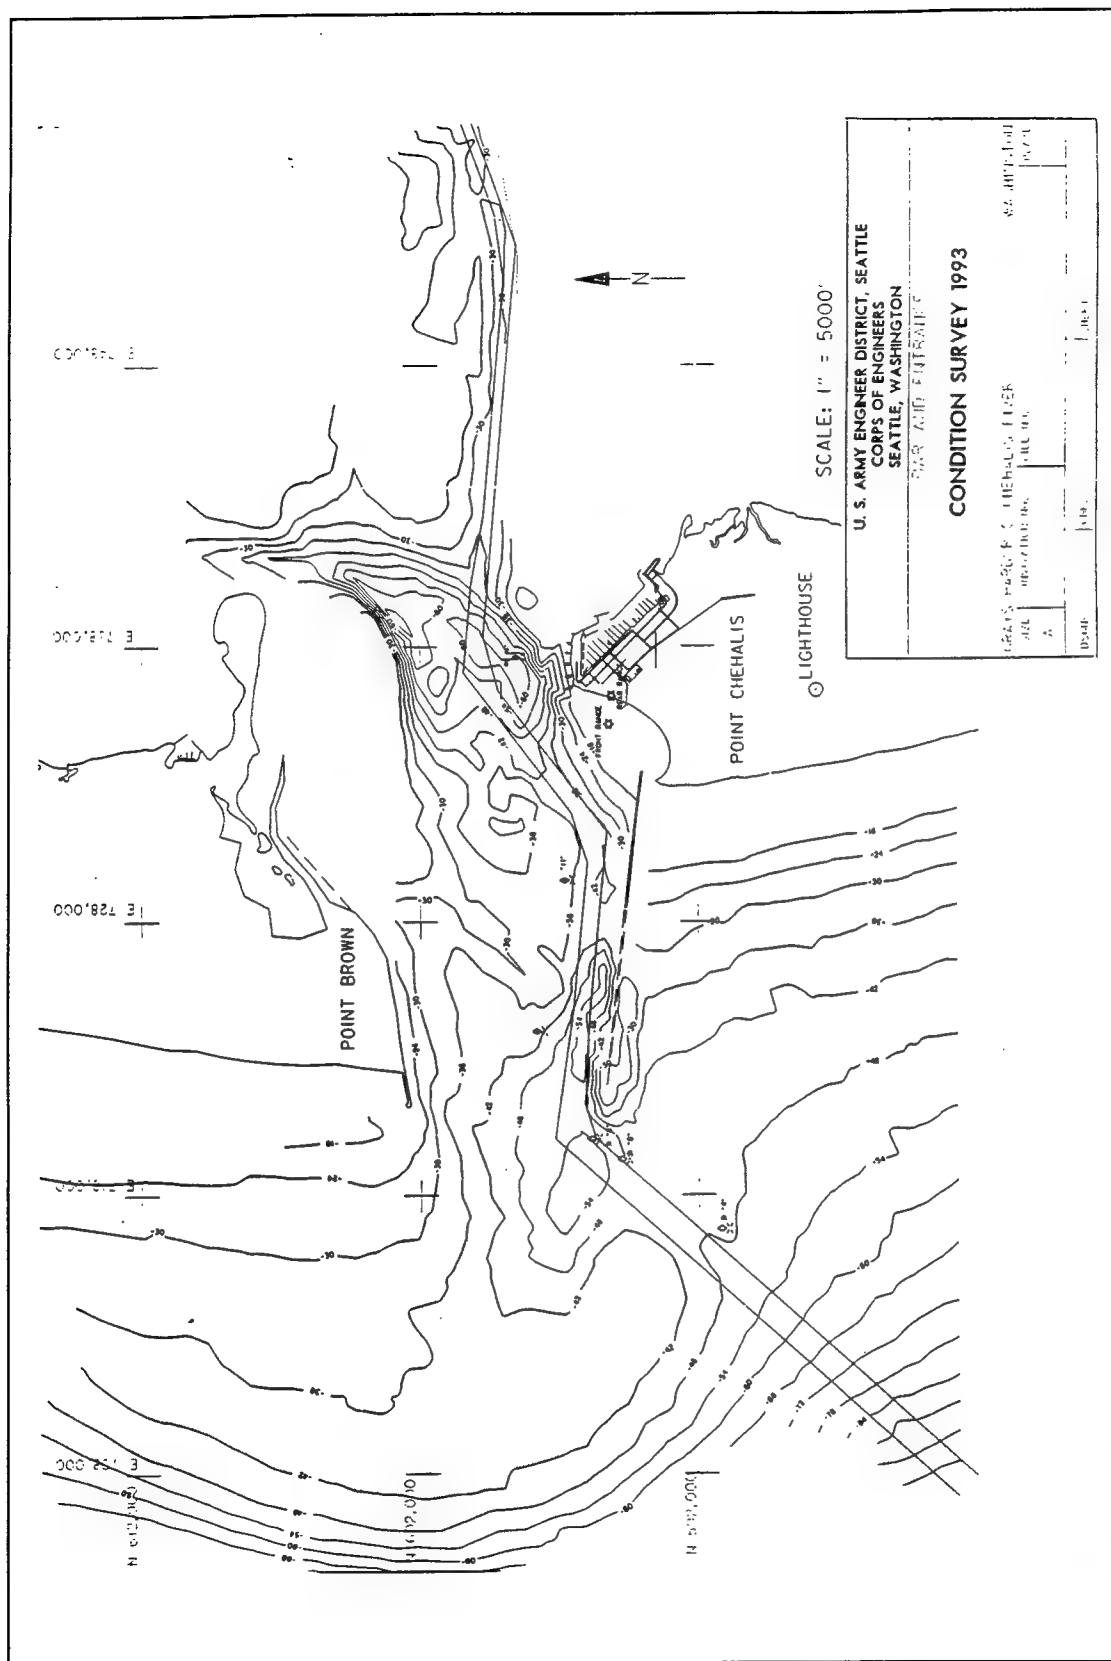
Figure 9. Entrance configuration in 1993

21. Figure 9 shows the December, 1993 configuration of the entrance including the recent breach at the east end of the south jetty. The trends

shown in the previous figures continued. South Beach was eroded, Half Moon Bay was enlarged, and North Beach was filled westward nearly to the outer end of the north jetty. The shallowest contour on the outer bar is -42 ft (the contour interval is 6 ft).

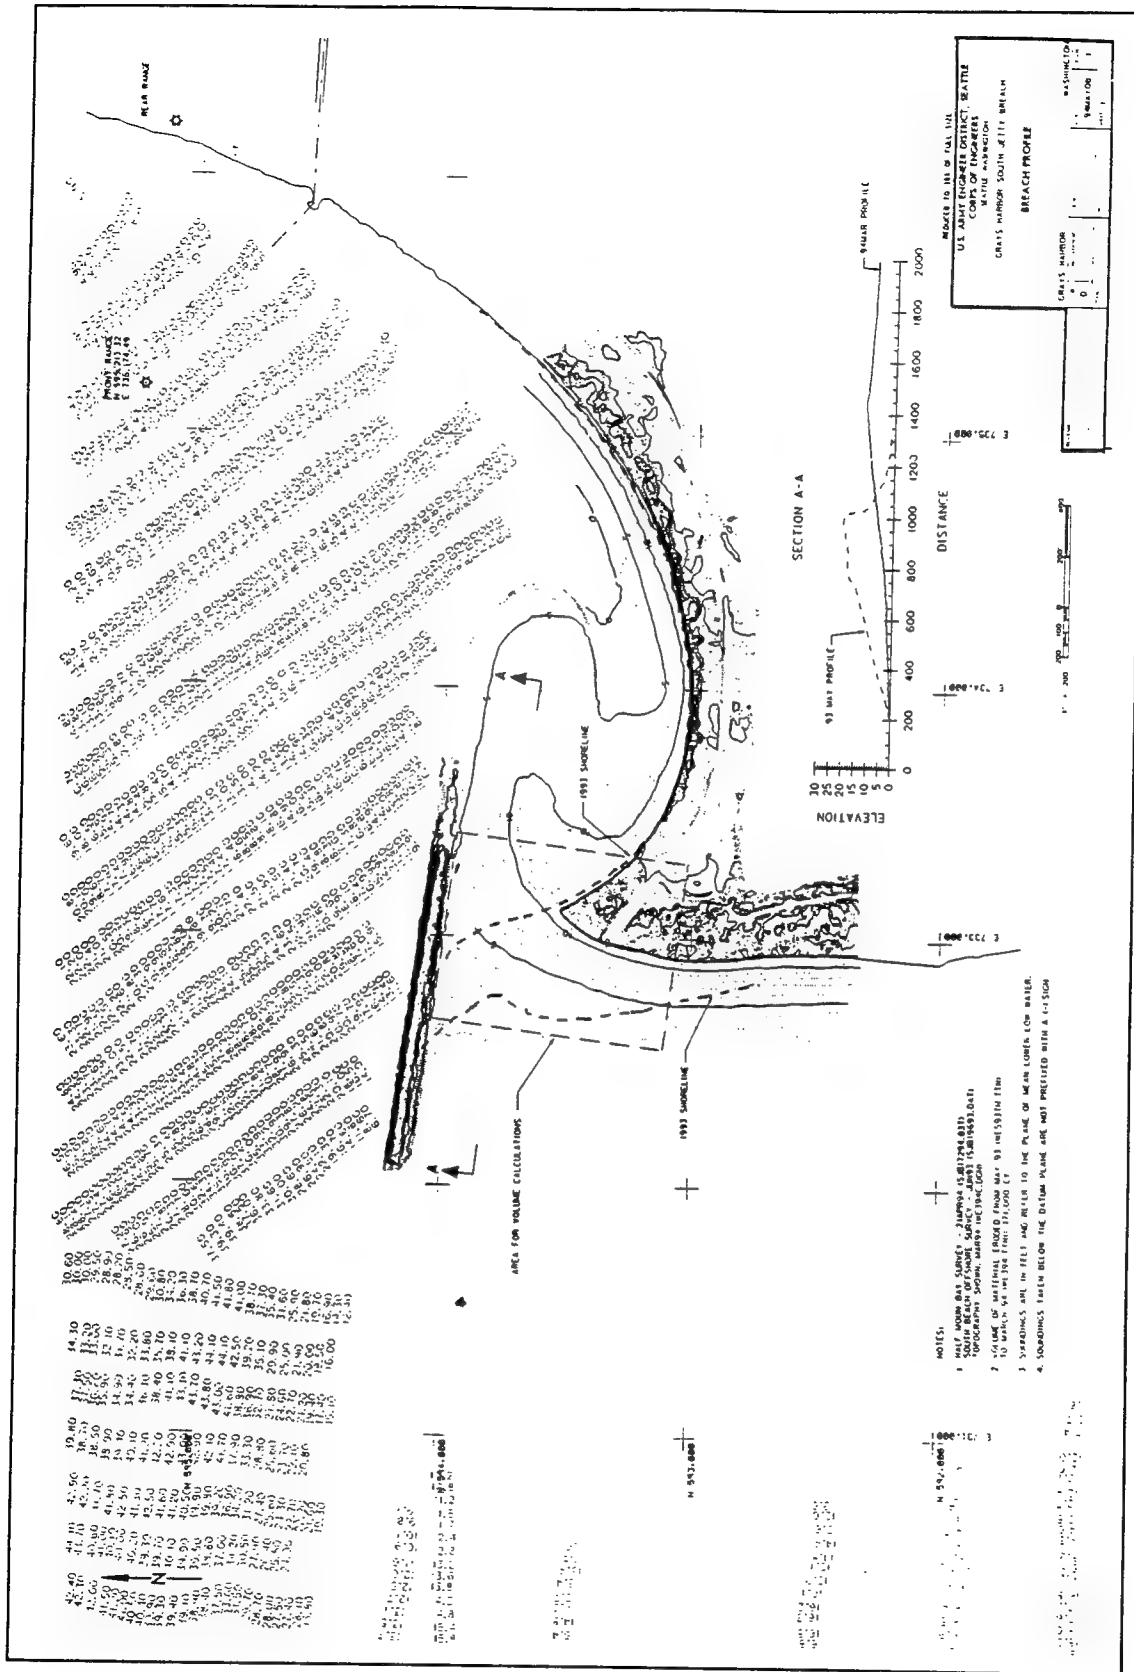
Figure 10. Breach and deposit in Half Moon Bay

22. The breach occurred during a storm on December 10, 1993. The storm started on the evening of December 8 and lasted until December 15 (Hartman Associates 1994, p 7). The maximum significant offshore wave height was recorded by the Grays Harbor buoy at 0230 December 10. The wave height was 25 ft and the period was 13 seconds. The direction of offshore waves varied from 33 to 91 degrees relative to the shore. Hartman & Associates calculated the largest wave height at the 33-ft depth to be 16.7 ft with a length of 450 ft. They calculated a wave recurrence interval of two years. Evidently, setup from south winds combined with high waves caused overtopping of the narrow portion of the spit between South Beach and Half Moon Bay. Much of the material that was washed out of the breach has deposited in Half Moon Bay. Figure 10 shows details of the breach in May, 1994.

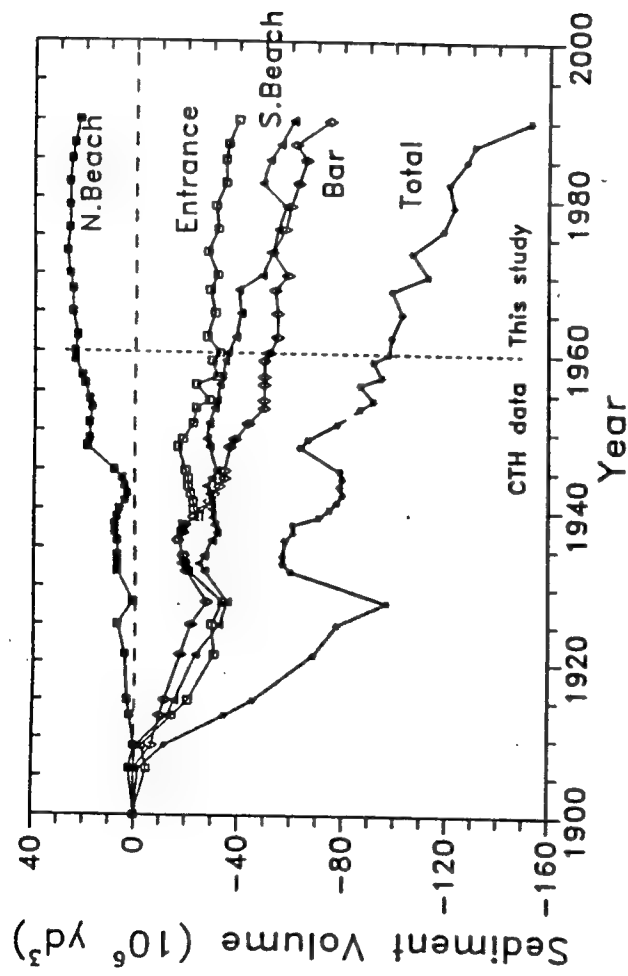
Figure 13. Historic volume changes for selected areas (from Battelle/Marine Sciences Laboratory 1992)

38. The plot of total volumes in Figure 13 shows continuing loss of sand from the region over a period of ninety years. This period is too long to attribute the loss to cyclic causes, such as variability of winter weather. It is most likely a result of the impacts of the jetties on the areas included in the computation. The jetties first caused erosion of sand from the entrance and its deposition on the bar, where it was subsequently eroded by waves and coastal currents. Sand that entered the entrance from North Beach crowded the entrance channel until velocities were sufficient to carry additional sand seaward or landward beyond the areas included in the calculation. Waves in the entrance must also have contributed to movement of sand. And finally, South Beach was deprived of a sand supply and subjected to erosion as described in paragraph 31.

Sediment-Volume Changes for the Period 1900 Through 1990 from Combined Data of the Committee on Tidal Hydraulics Report and This Study.
